# POTENTIAL APPLICATION OF DEEP LEARNING AND UAS FOR GUARDRAIL SAFETY INSPECTION

## ABSTRACT

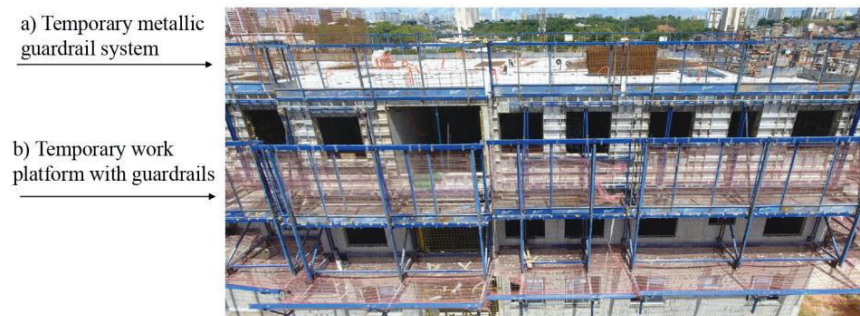
Figure 2: Safety Systems with Guardrails in the Construction Site

The temporary guardrail at the edge of the slab and in the contour of openings in the work area. This system comprises metallic guardrail panels 120 cm minimum high with a toe board supported on the surface (15 cm tall) and guardrail posts fixed on the formwork;

The temporary work platform with guardrails, allowing workers to perform their activities around the story under construction. This system is also fixed on the formwork. The components are work platform consoles, metallic board (floor), metallic guardrail panels with toe board (attending the minimum specifications of the system), and guardrail posts.

As the formwork system is industrialized, the construction industry has adopted temporary metallic guardrail systems for cast-in-place concrete wall systems. In general, there are two safety systems in this type of construction using guardrails (Figure 2):

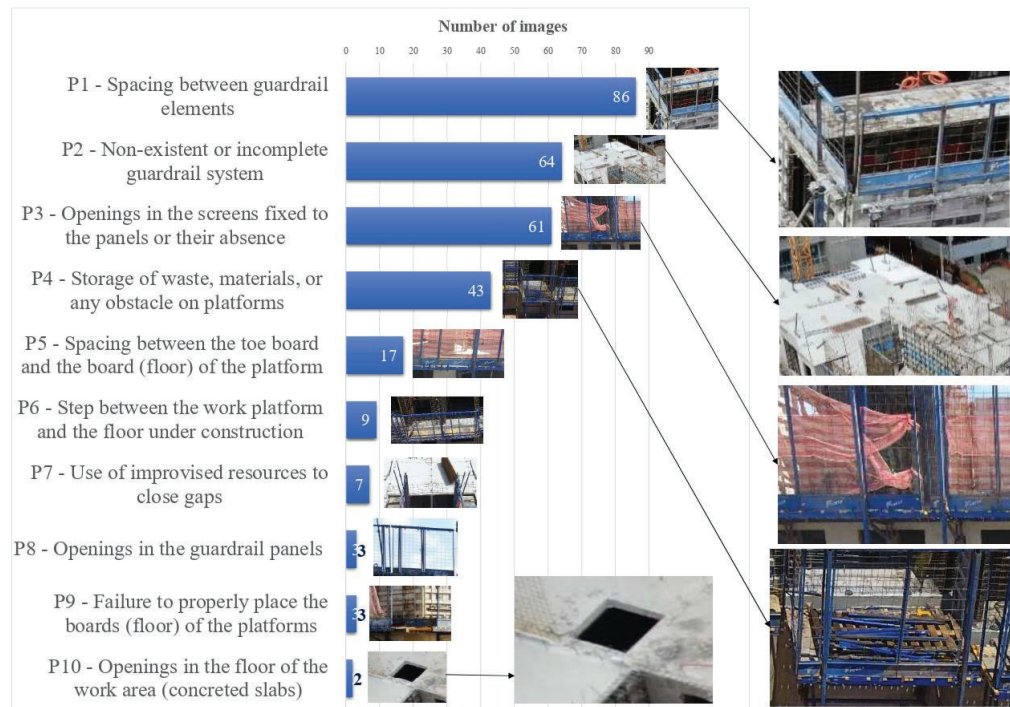
Figure 3: Types of Problems in Temporary Guardrail Systems and Work Platforms

Based on the analysis of the 90 images from the database by the safety specialists, ten types of safety problems related to temporary guardrails and temporary work platforms with guardrails were identified. The issues and the number of images in which each issue appears are shown in Figure 3.

According to Figure 3, problem P1 (spacing between guardrail elements) was identified in 95.5% of the images, while P2 (non-existent or incomplete guardrail system), P3 (openings in the screens fixed to the panels or their absence), and P4 (storage of waste, materials, or any obstacle on platforms) were identified in 71.1%, 67.8%, and 47.8% of the images, respectively. Problems P5 to P10 were identified in less than 20% of the photos.

From the ten problems identified in the falling protection systems used in the cast-in-place concrete wall, problems P1 to P4 appeared more frequently in the images. In contrast, the other problems (P5 to P10) appeared with significantly lower frequency. According to ML/DL specialists' perception of which problems have the most significant potential for automatic detection by ML/DL algorithms, they highlighted: P1 (Spacing between guardrail elements), P2 (Non-existent or incomplete guardrail system), and P3 (Openings in the screens fixed to the panels or their absence). Despite the P10 (Openings in the floor of concreted slabs) being identified by the ML/DL specialists as a problem with great potential to be recognized by ML/DL techniques, it showed low occurrence in the analyzed images. It results in more difficulty using the ML/DL algorithm since there is a need for many images with the referred problem to train it. Thus, this research focused on problems P1 to P3 since they present the most potential to identify using ML/DL and appear more frequently in the images.

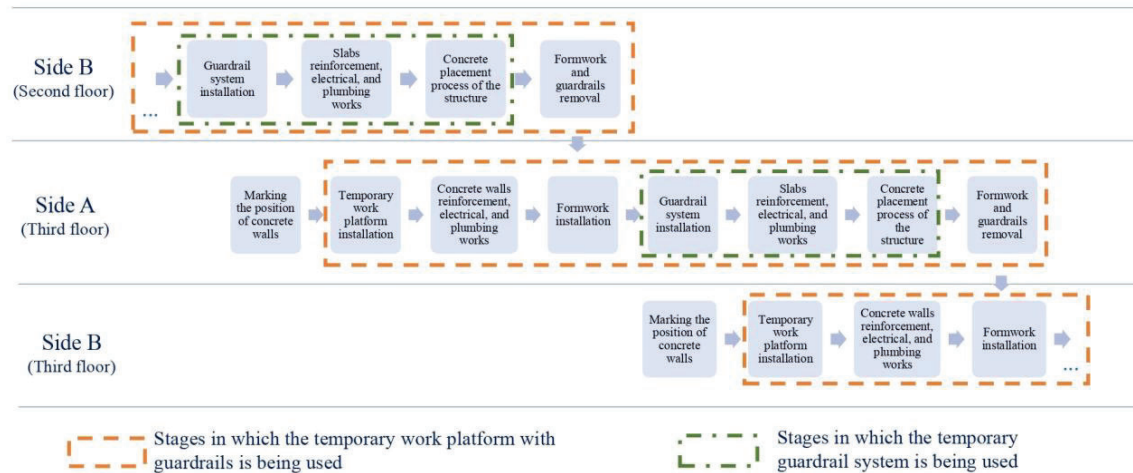
Figure 4: Production Activities of the Structure

The sequencing of activities related to the production of the cast-in-place concrete wall system of the unit case is presented in Figure 4. The execution of the structure of each floor occurred in two stages, with side A and side B being built at different times. The company had only a set of formwork (for half of the story). Thus, after concreting the walls on side A and the concrete reached the required design strength (generally around 12 hours), the formwork was removed from side A and positioned on side B. Side B should already have the wall reinforcements, electrical, and plumbing ready to receive the formwork of the walls and continue the activities. When the forms on side B were removed (after the concrete had hardened), they were taken to the continuity of activities on side A of the upper floor.

Figure 4 shows the activities that integrate the executive sequencing adopted for building each side of the story in the analyzed site. This sequencing was applied from the construction of the second floor to the top floor, in which the installation of the temporary work platform with guardrails became essential. In Figure 4, it is also possible to observe which safety systems were used or were available for use during the execution of each of the activities.

In the process adopted at this construction site, it is observed that only during the activity of marking the position of concrete walls is there no guardrail system or temporary work platforms with guardrails on this side of the construction floor. Lifeline systems were implemented in the construction area for the workers' safety in this activity.

Based on the constructive sequence presented in Figure 4, using UAS and ML/DL to inspect temporary work platforms with guardrails should be carried out at any time during the execution of cast-in-place concrete wall systems. This flow of activities indicated that at least one side of the building would have this falling protection system installed and used (Figure 5). Regarding temporary guardrail systems, their use appears in specific stages of the work, meaning their inspections will take place at particular stages of the structure's production (Figure 4).

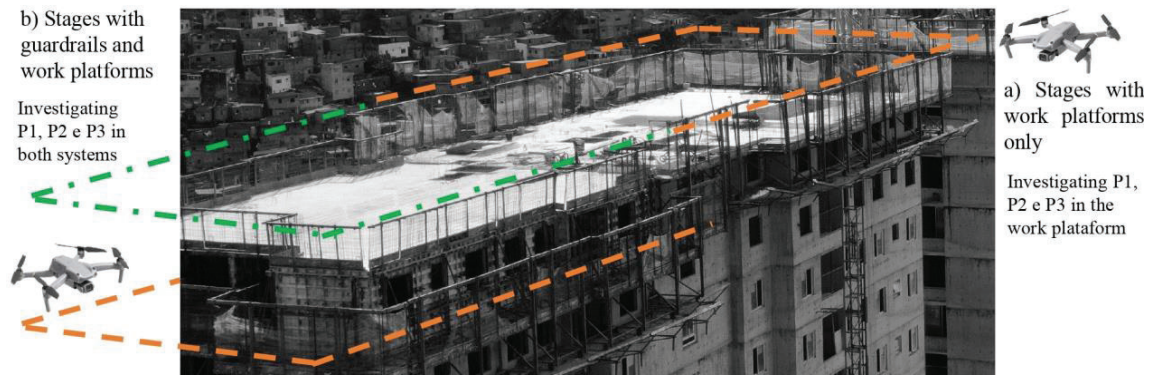
Figure 5: Different Stages for Collecting Data in the Construction Site

This analysis was essential to understand the moments that guardrail inspection should be performed, avoiding unnecessary inspections and consequently reducing non-value-added activities (Womack & Jones, 2003). Thus, the inspection frequency of the safety systems depends on the structure's production rhythm. Therefore, the safety systems should be inspected at a minimum when each story's installation has been concluded.
